City of Biggs

TO: Honorable Mayor and Members of the City Council
FROM: Mark Sorensen, City Administrator
Subject: Authorization to purchase water well services.

TECHNICAL MEMORANDUM

TO: Mark Sorensen, Trin Campos
FROM: Mike Massaro, Steven Ainsworth, Gabriel Rodriguez
DATE: April 7, 2016
SUBJECT: C Street Well – Short Term Strategy
PROJECT: 11-416-12 City of Biggs – C Street Well Assessment

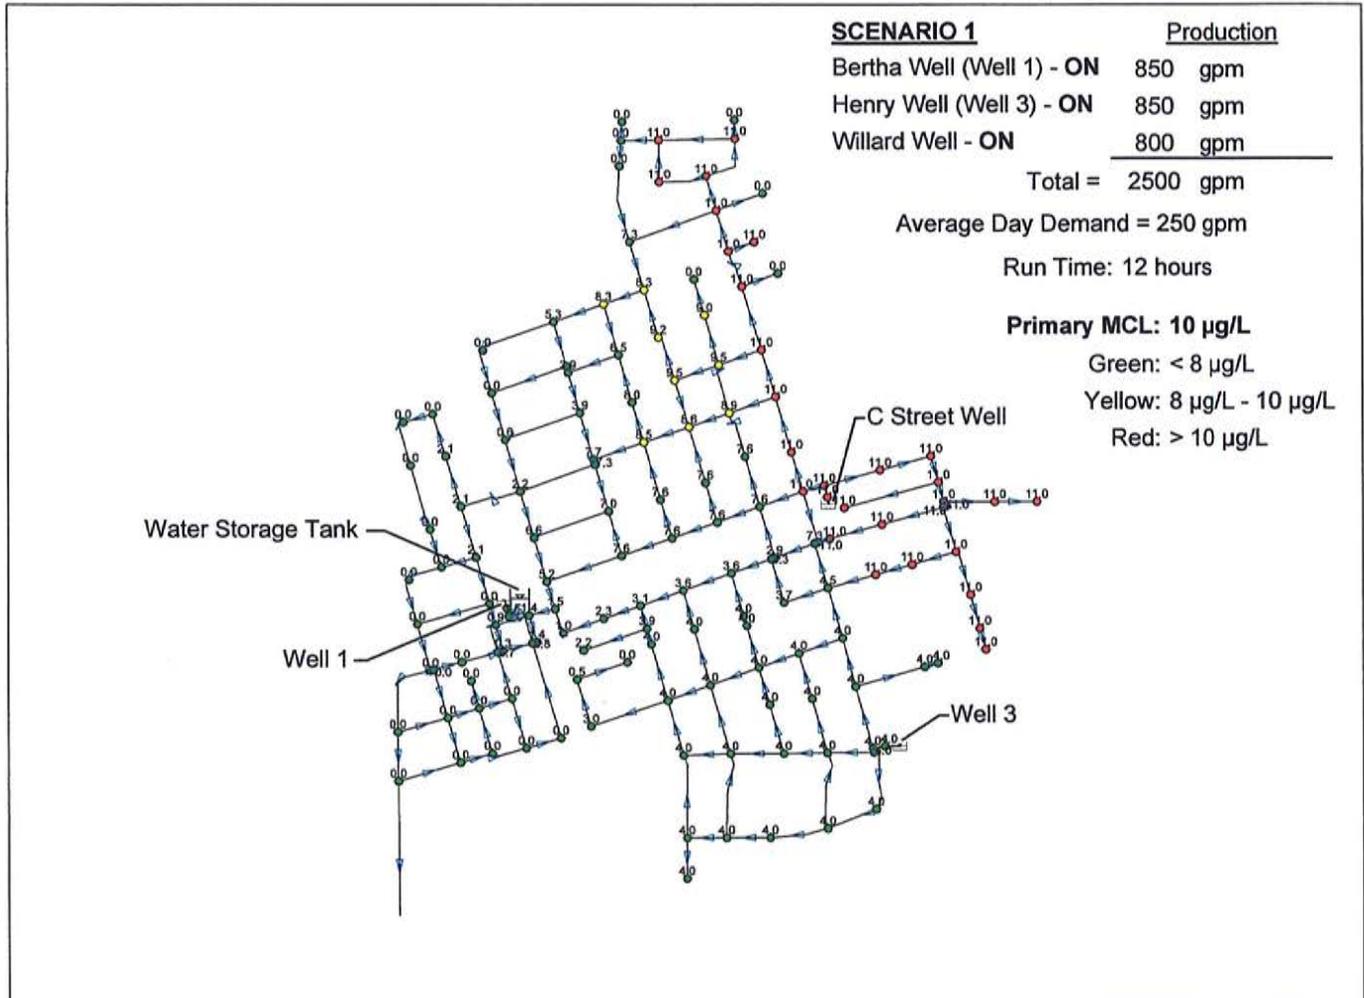
Biggs Water Model - Arsenic (Scenario 1)

All scenarios were performed with run durations of 12 hours. Results for arsenic and manganese from each scenario are displayed on the attached system maps. Green nodes indicate points of compliance, yellow points are compliant but nearing noncompliance, and red nodes are above the maximum contaminant level (MCL), or noncompliant. Time-dependent graphs showing specific junctions in the water system at three different locations under all scenarios for arsenic and manganese are attached in the Appendix.

- Scenario 1 – Bertha on, Henry on, Willard on
- Scenario 2 – Bertha on, Henry off, Willard on
- Scenario 3 – Bertha off, Henry on, Willard on
- Scenario 4 – Bertha on, Henry on, Willard off

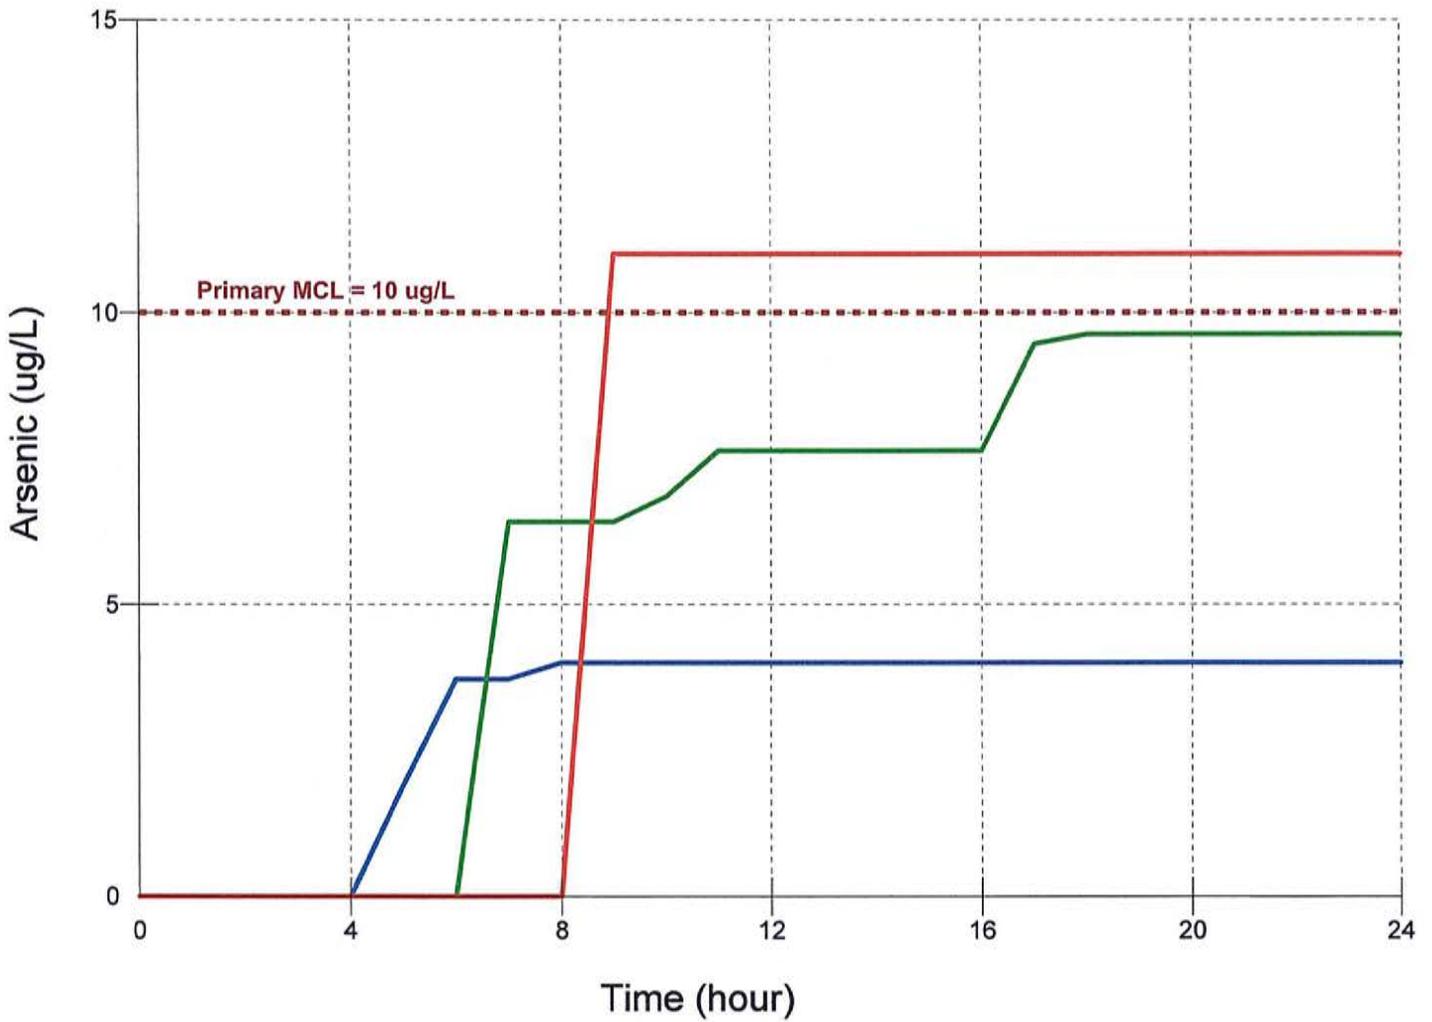
Scenario 1 - Arsenic

1410 (Third St & Bannock St) 1670 (Sixth St & C St) 1880 (Second St & J St)

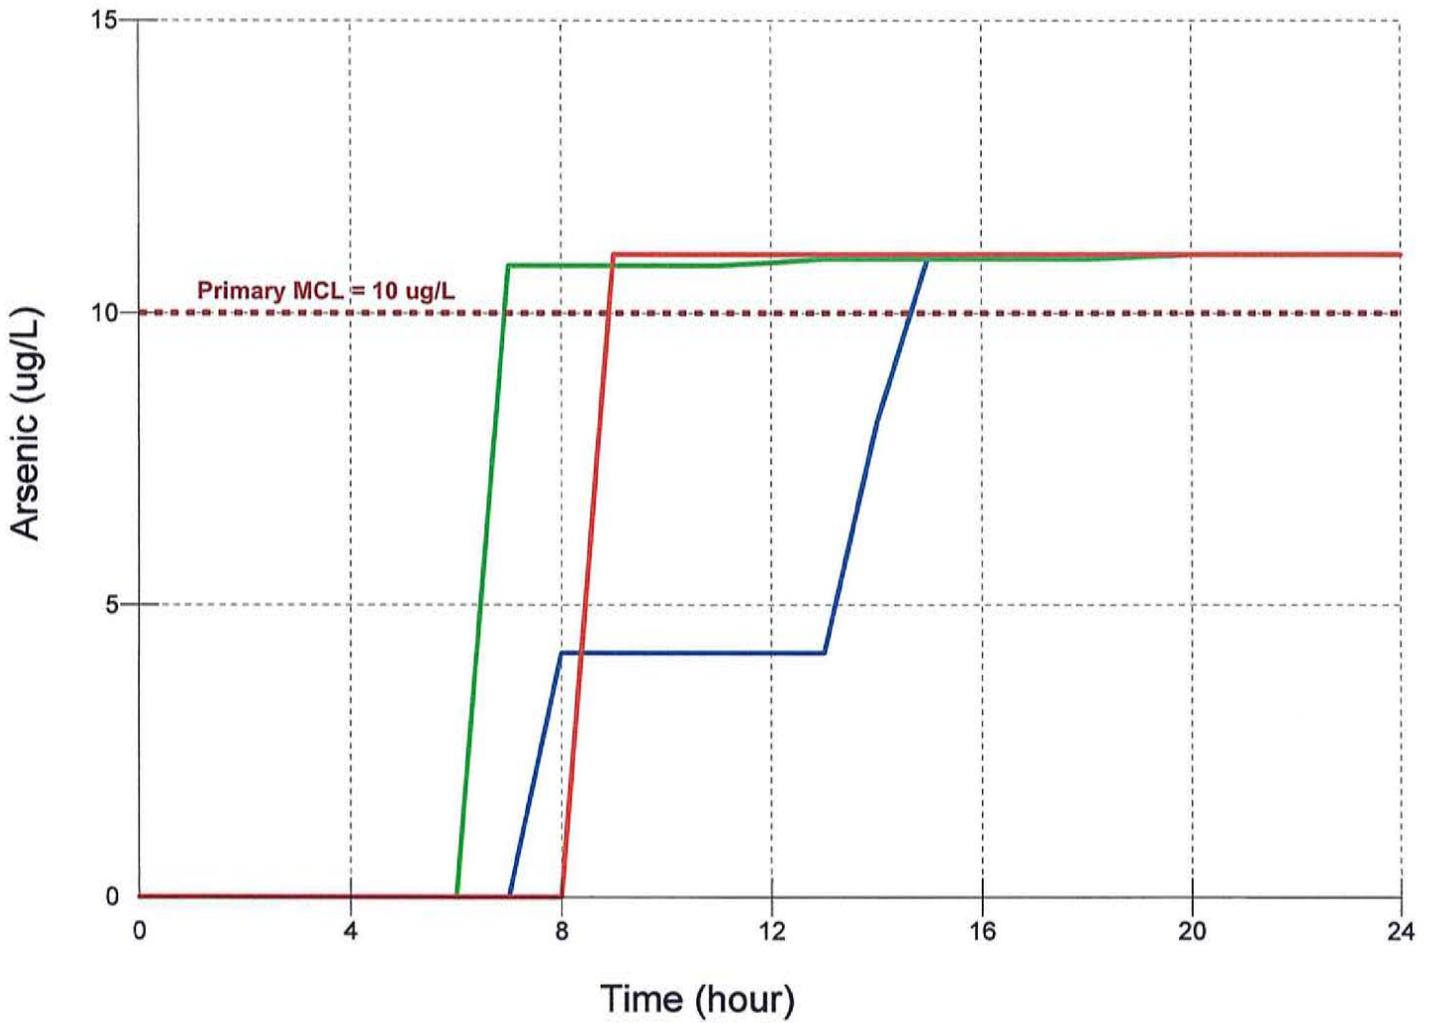
Scenario 2 - Arsenic

1410 (Third St & Bannock St) 1670 (Sixth St & C St) 1880 (Second St & J St)

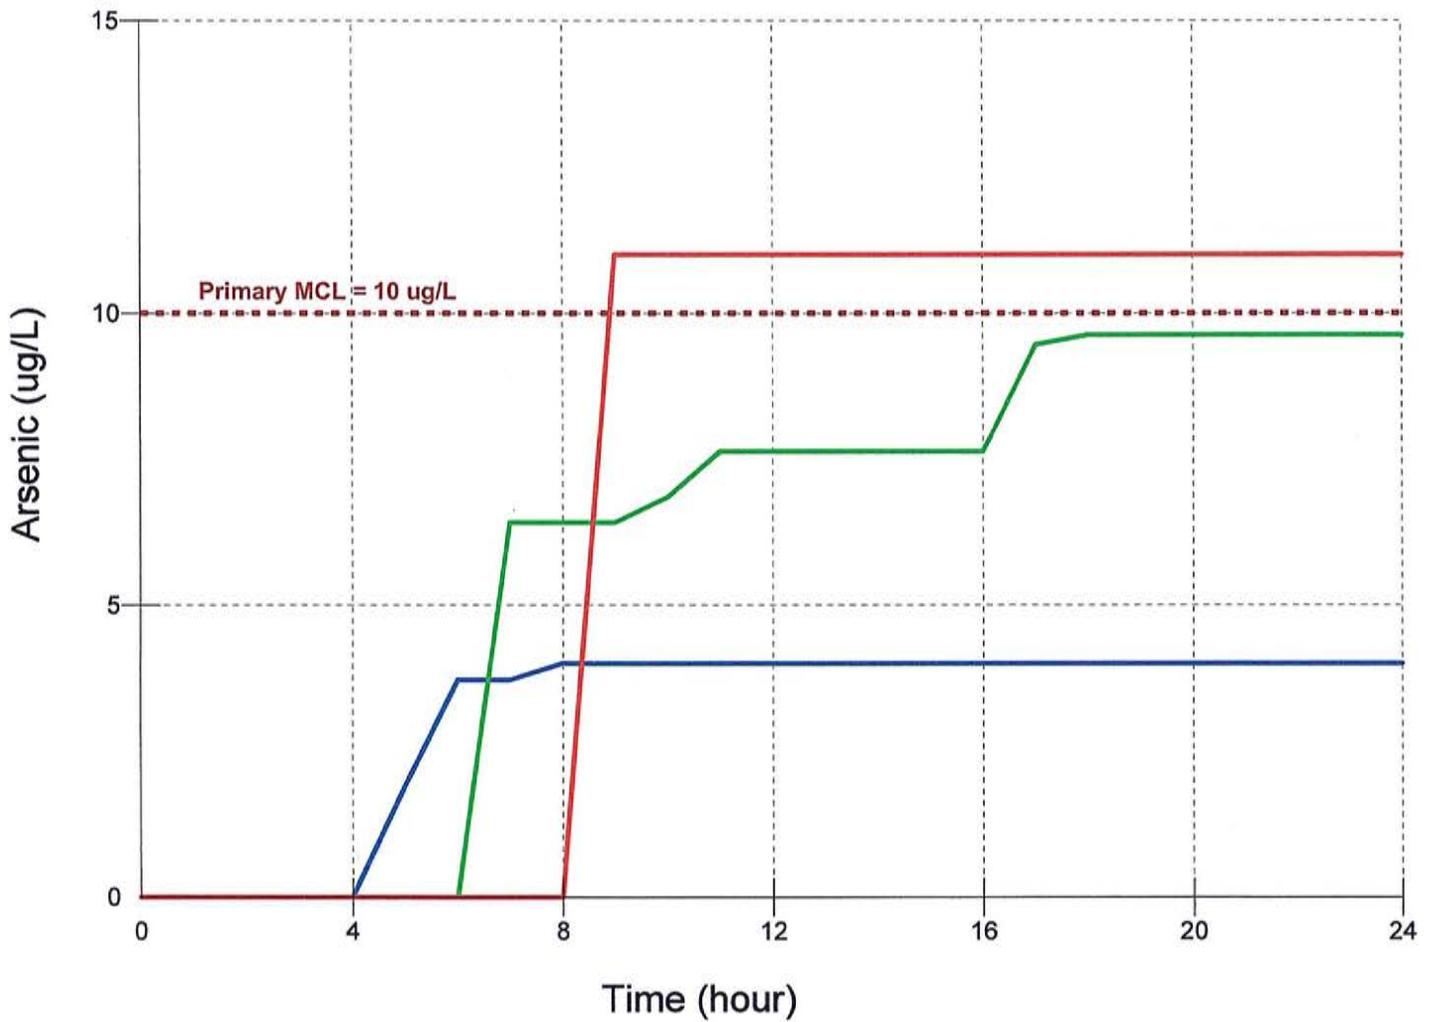
Scenario 3 - Arsenic

1410 (Third St & Bannock St) 1670 (Sixth St & C St) 1880 (Second St & J St)

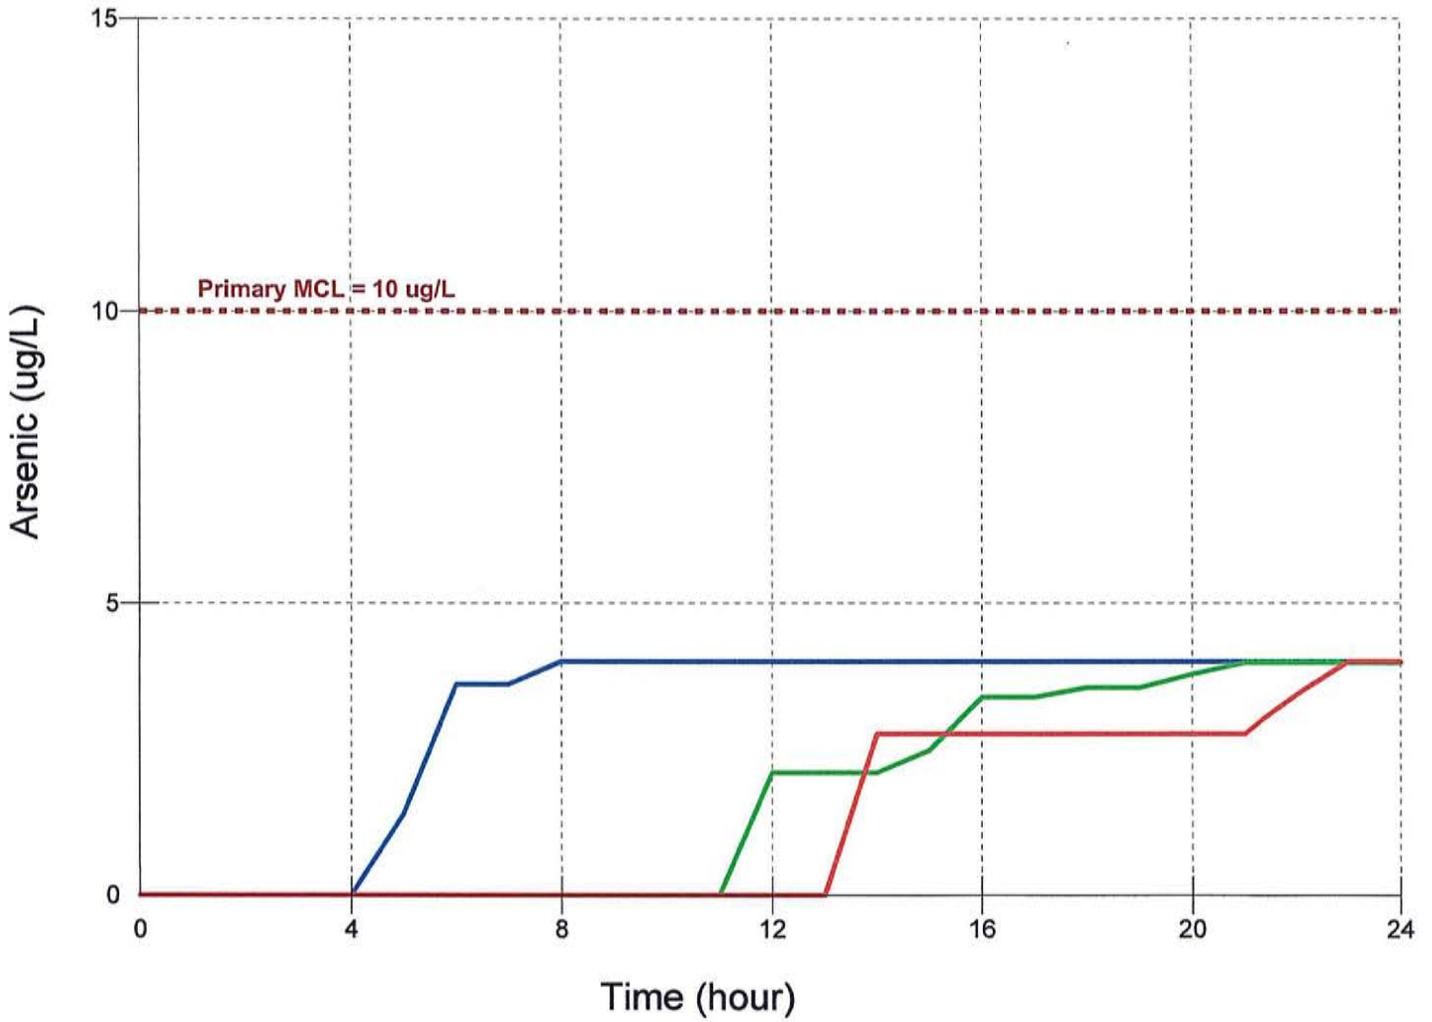
Scenario 4 - Arsenic

1410 (Third St & Bannock St) 1670 (Sixth St & C St) 1880 (Second St & J St)

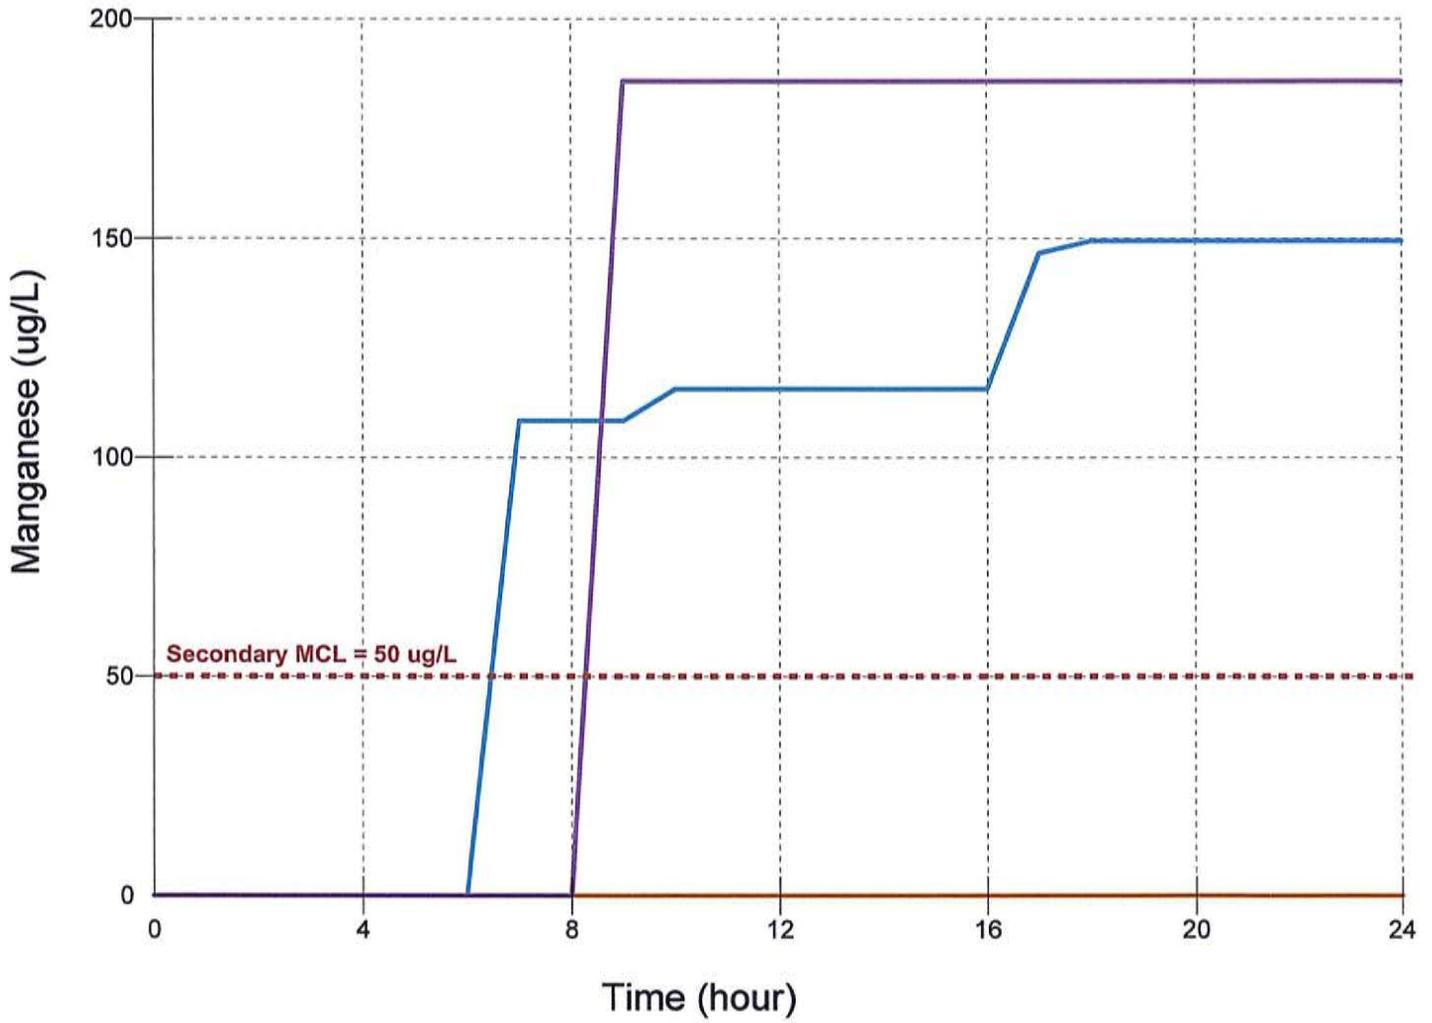
Scenario 1 - Manganese

1410 (Third St & Bannock St) / 1670 (Sixth St & C St) / 1880 (Second St & J St)

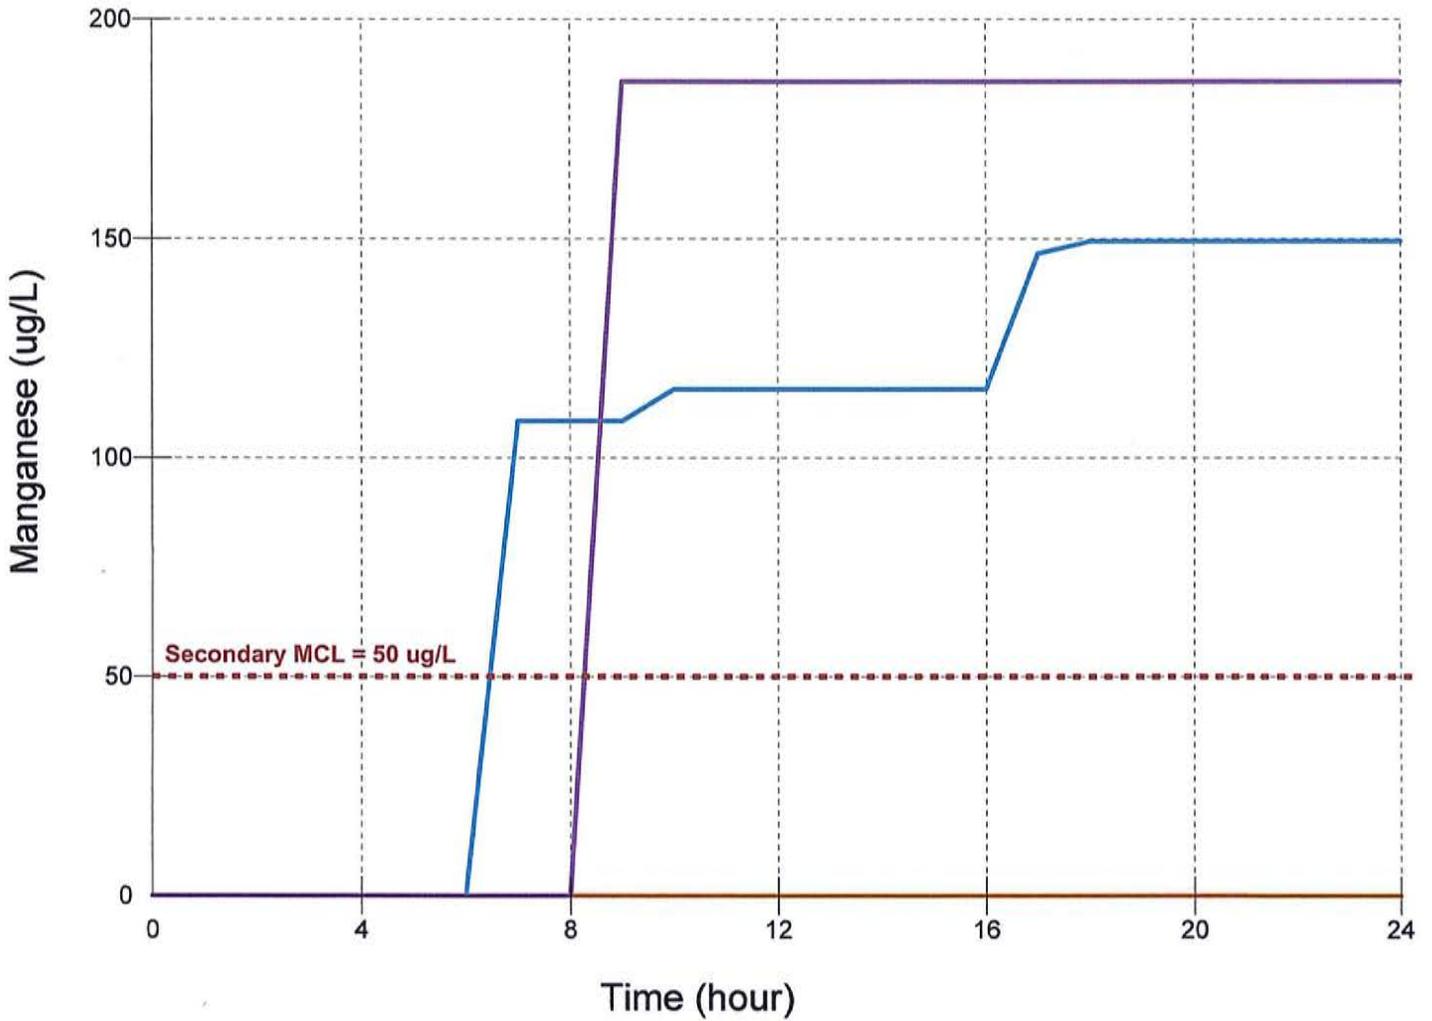
Scenario 2 - Manganese

1410 (Third St & Bannock St) / 1670 (Sixth St & C St) / 1880 (Second St & J St)

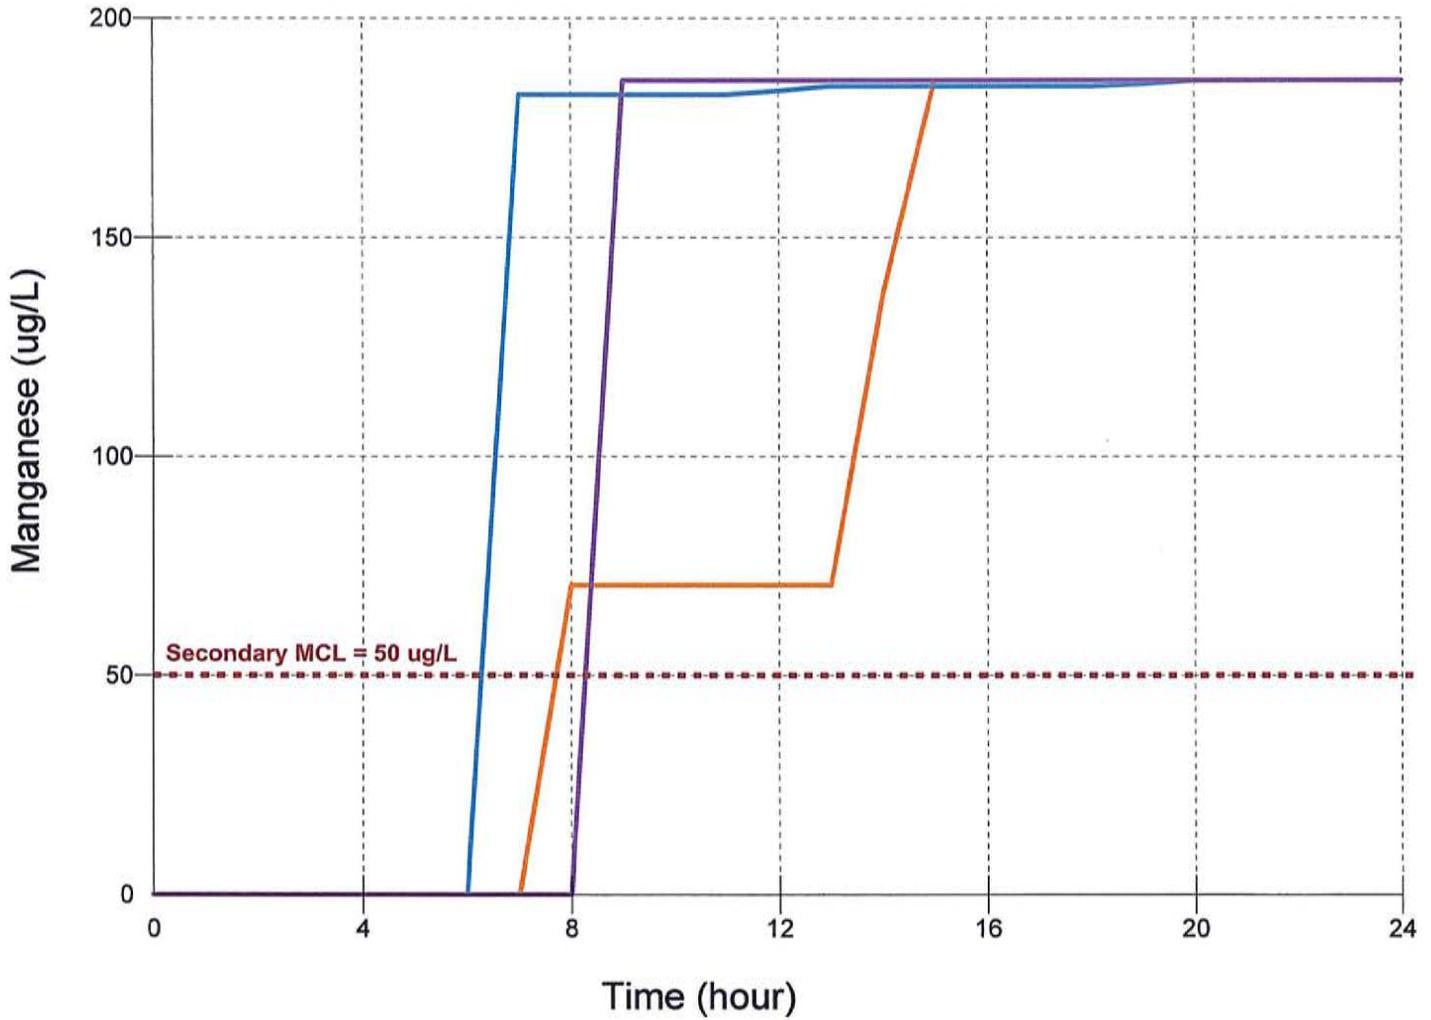
Scenario 3 - Manganese

1410 (Third St & Bannock St) / 1670 (Sixth St & C St) / 1880 (Second St & J St)

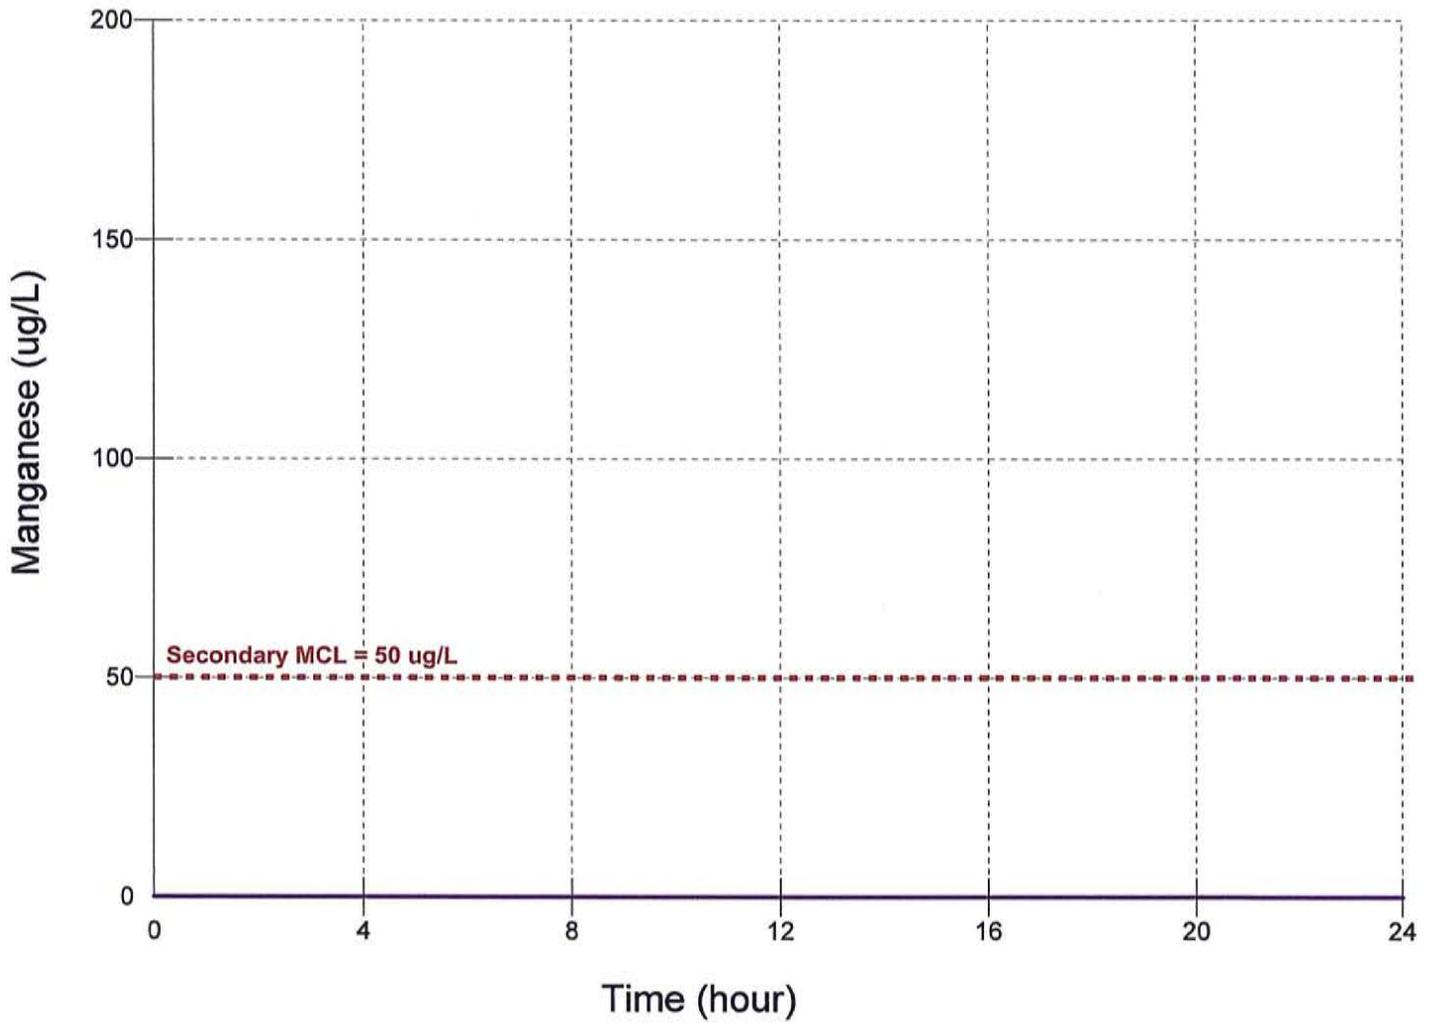
Scenario 4 - Manganese

1410 (Third St & Bannock St) / 1670 (Sixth St & C St) / 1880 (Second St & J St)
